MTMC REPORT OA 81-4a-27

ANALYSIS OF MTMC PARTICIPATION IN THE REFORGER 81 EXERCISE

MAY 1982

MILITARY TRAFFIC MANAGEMENT COMMAND
TRANSPORTATION ENGINEERING AGENCY
 NEWPORT NEWS, VIRGINIA 23606

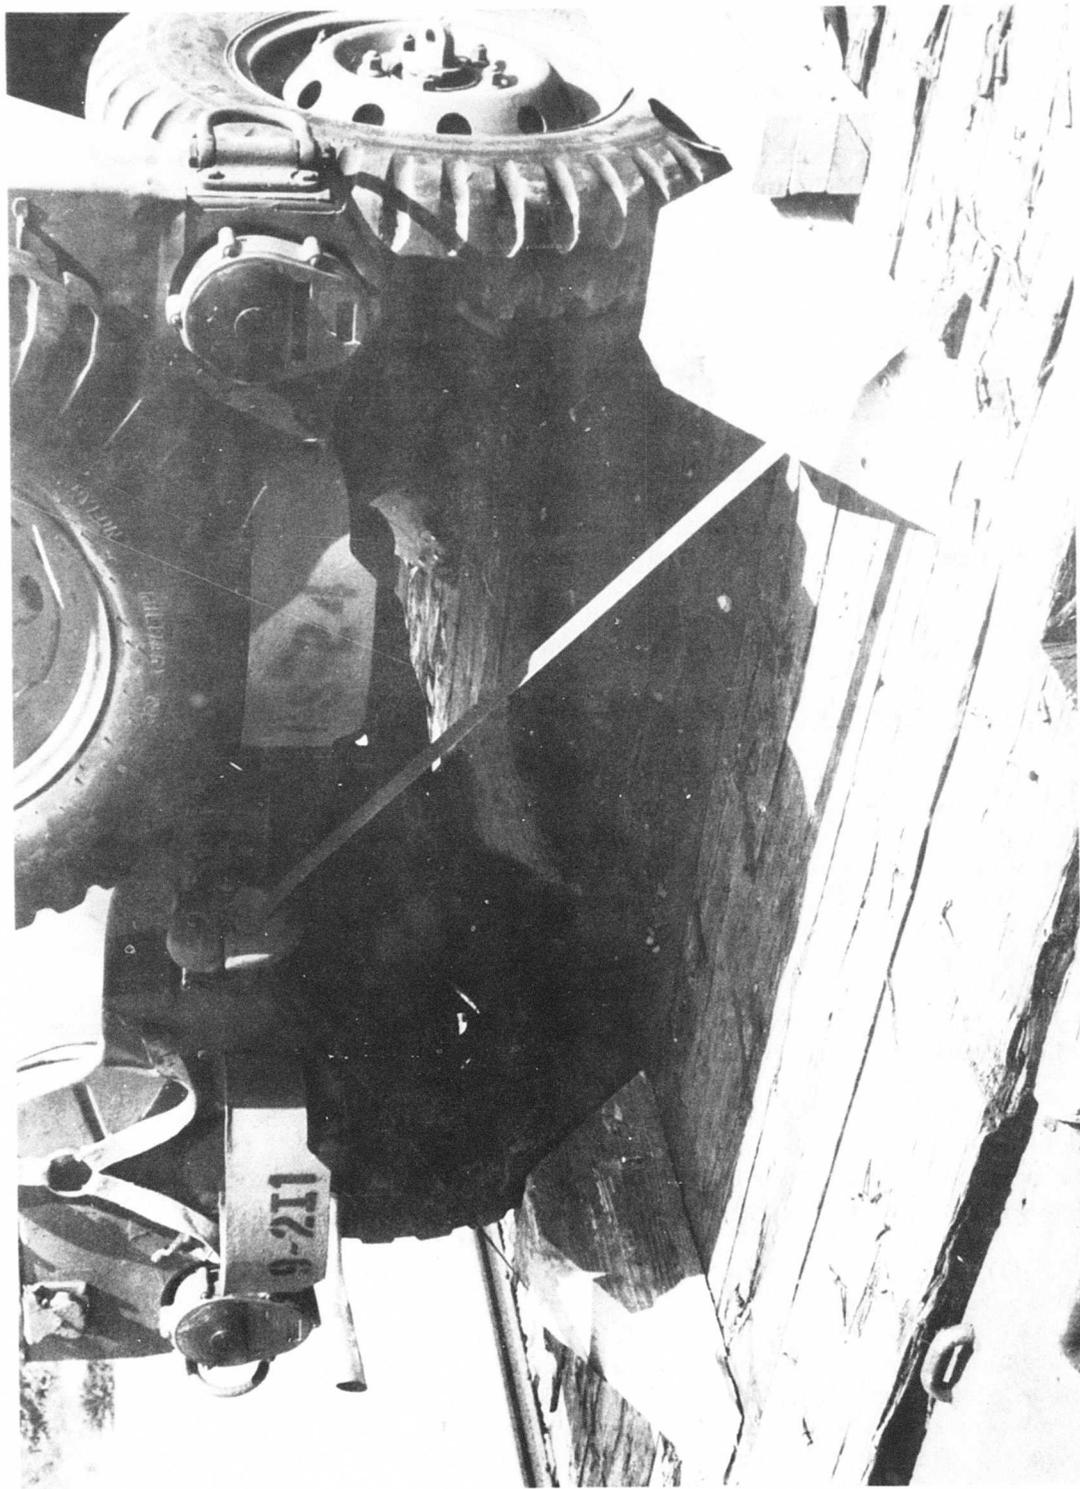
(2) Jeeps loaded on standard flatcars were secured with 1-inch banding (fig 4-2), in accordance with TM 55-2200-001-12, section 6, figure 49, item E; however, the banding was found to be broken upon arrival at the SPOE.

Figure 4-2. Jeep secured with 1-inch banding.

(c) Several 1-inch bands securing 1/4-ton vehicles onto the Fort Lewis train were broken in half, and a gamma goat had sustained damage to the tailgate and left side of cargo bed.

(3) Standard blocking and bracing methods using wire rope, instead of banding, be used to secure vehicles onto standard flatcars, and that TM 55-2200-001-12 be changed to reflect this recommendation.

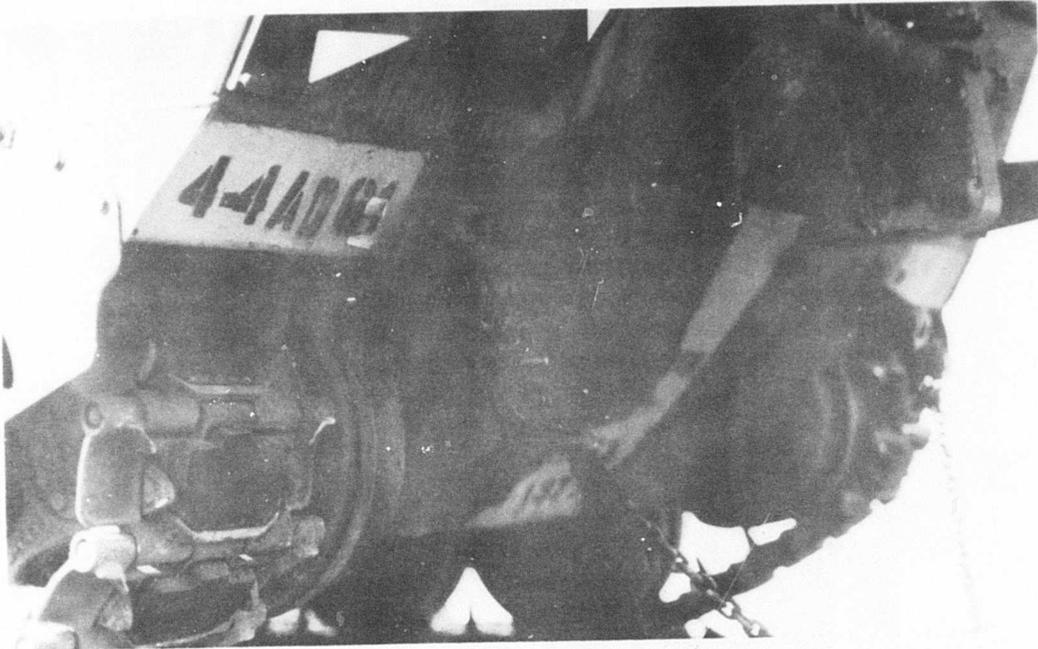
Figure 4-6. Vehicle fitted with "T" shackle instead of "U" shackle.

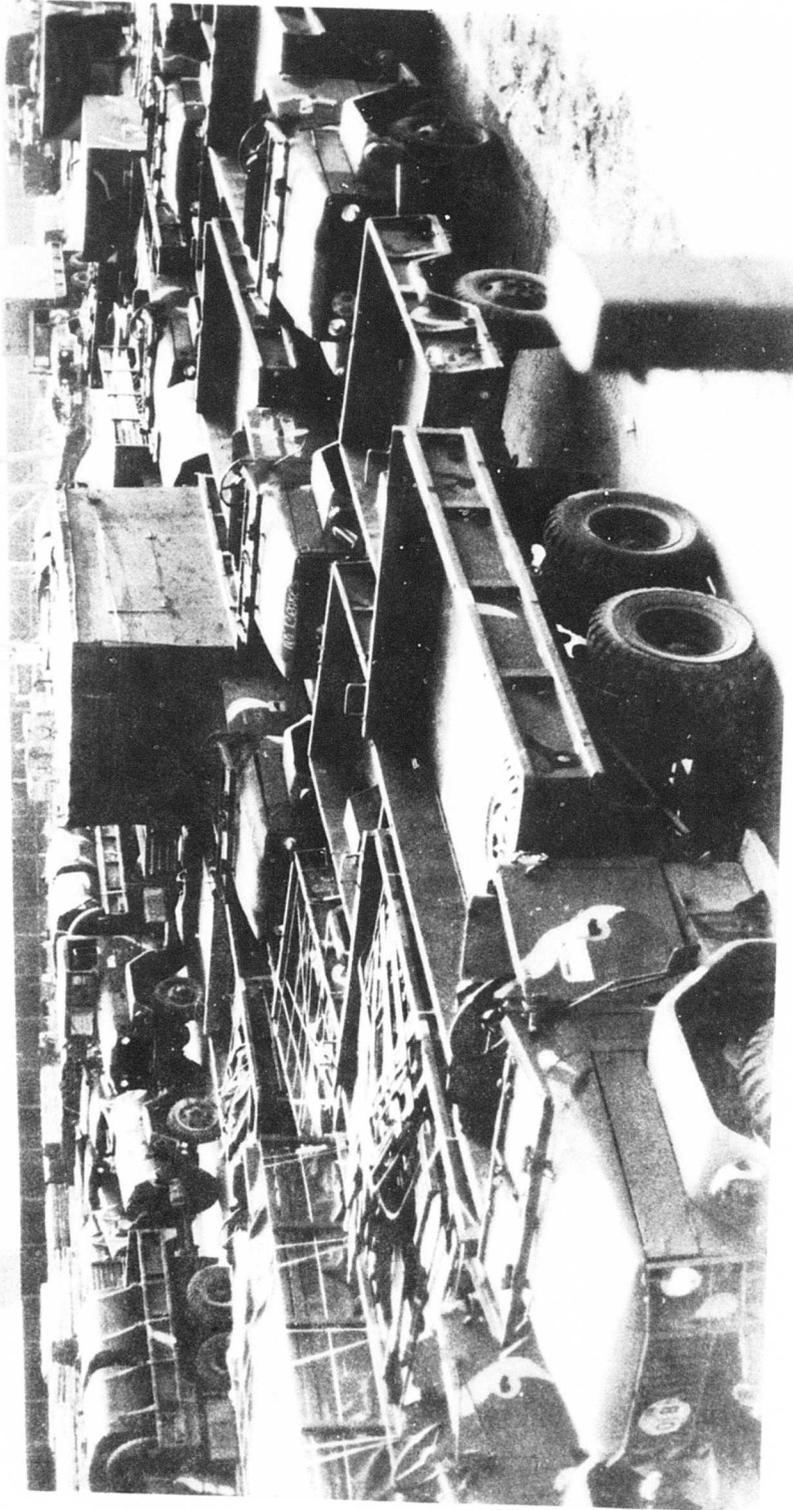
Figure 4-7. Vehicles with unused cargo space.

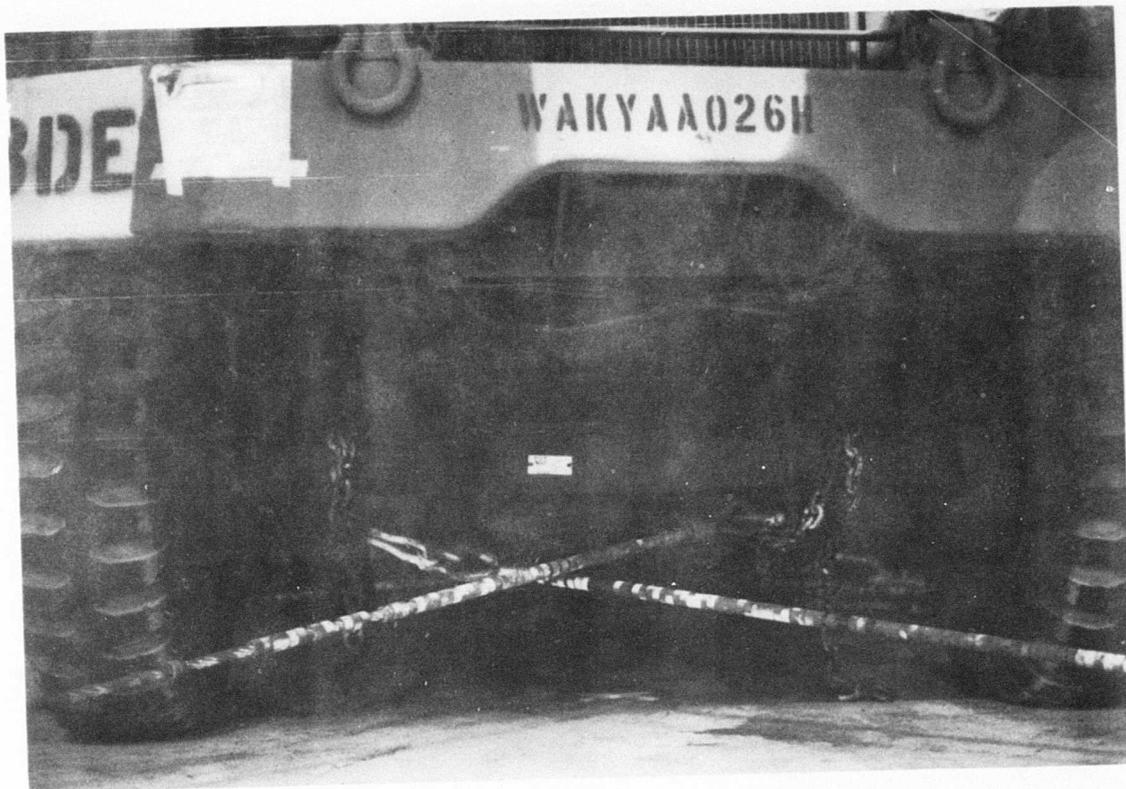
Figure 5-4. Lashings applied over axles on USNS Meteor.

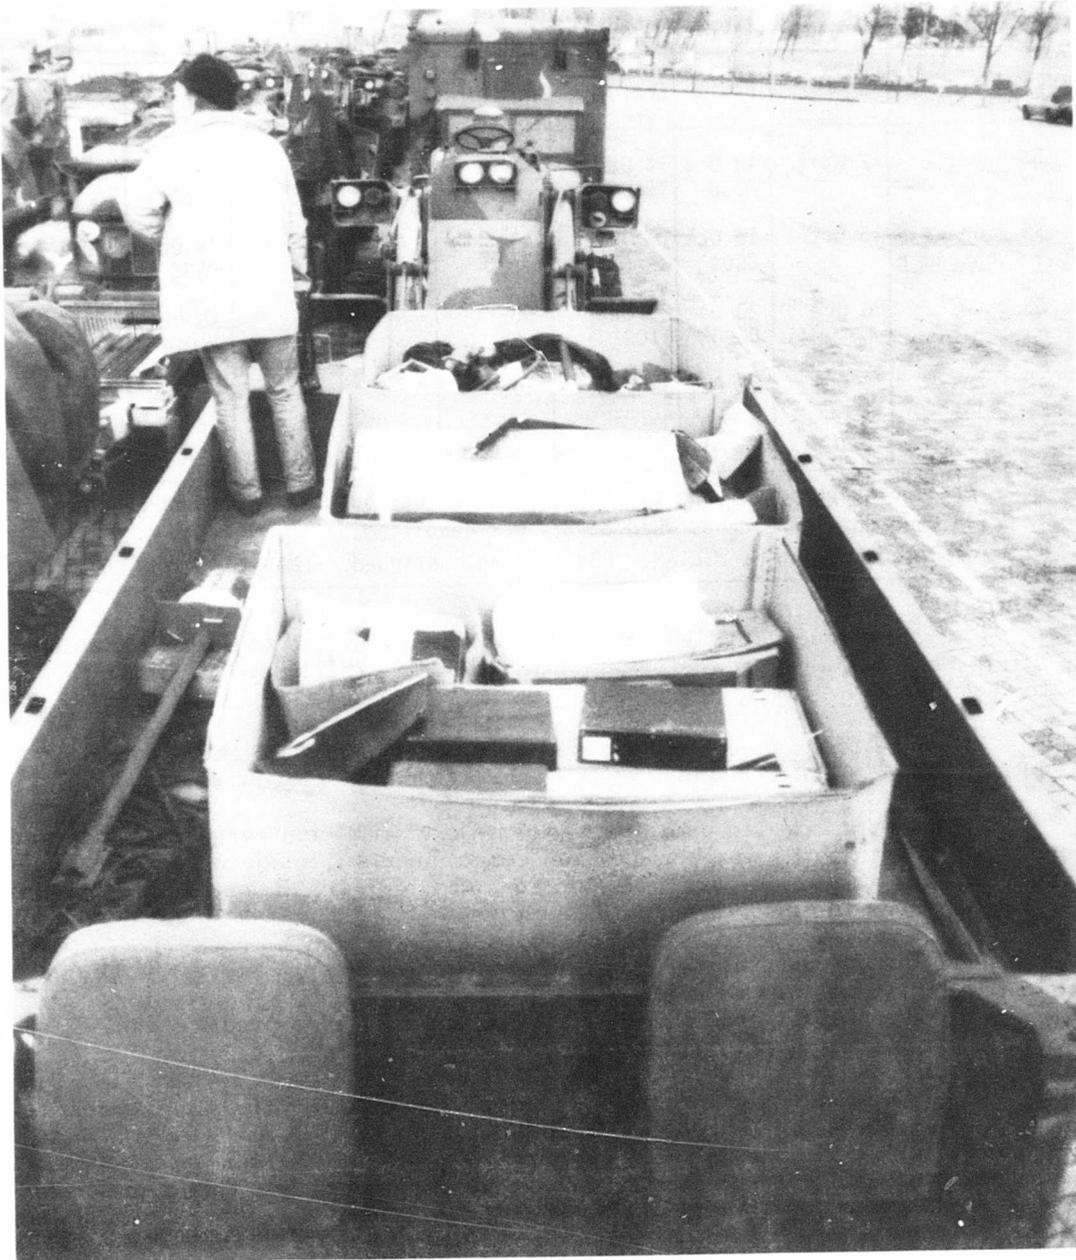
Figure 7-4. Cargo exposed to weather.

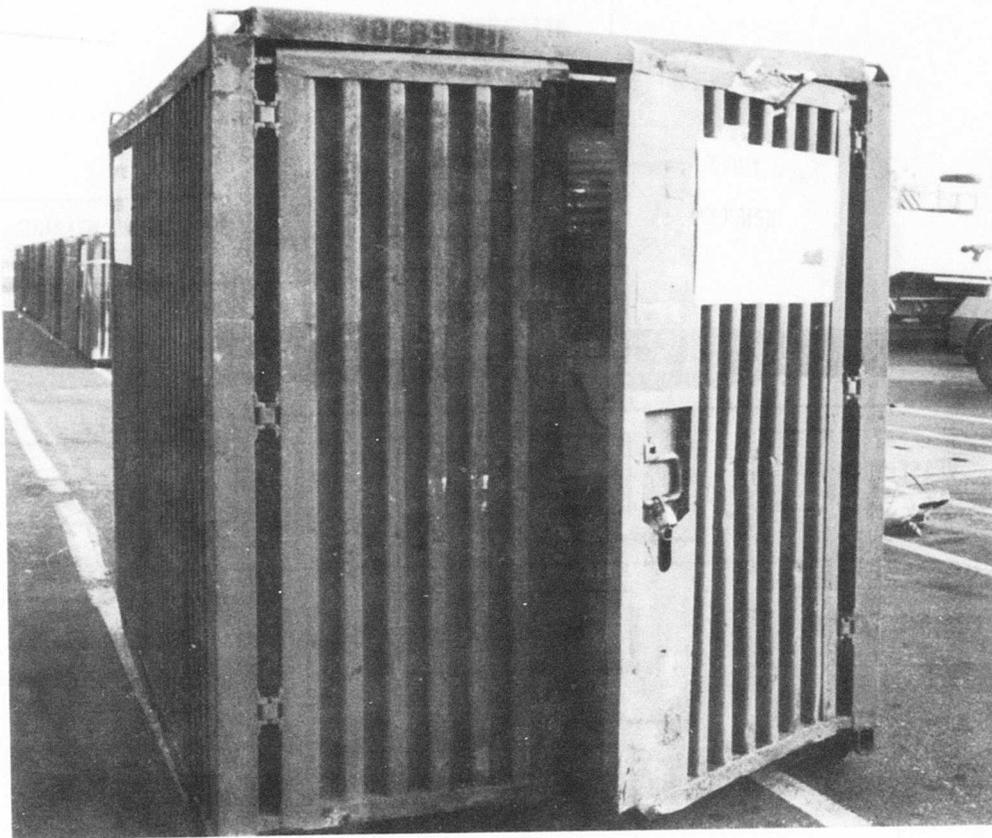
(3) Less than 50 percent of all CONEXs received were banded; however, all were locked. Fifteen unbanded CONEXs came open while being handled within the port. The apparent cause of the CONEXs opening was shifted loads.

- (2) The first ship to berth was the SS Buyer. Discharge operations were slowed by malfunctioning contractor's MHE. A number of vehicles had loose cargo in cargo beds. Three CONEXs, two of which were marked sensitive, arrived with open doors and no banding (fig 8-3). PSA personnel corrected these deficiencies.

Figure 8-3. Unbanded CONEX with door open.

(4) During the redeployment phase, more command emphasis be placed on insuring that returning equipment be properly and safely secured in all trailers, cargo beds, and CONEXs.

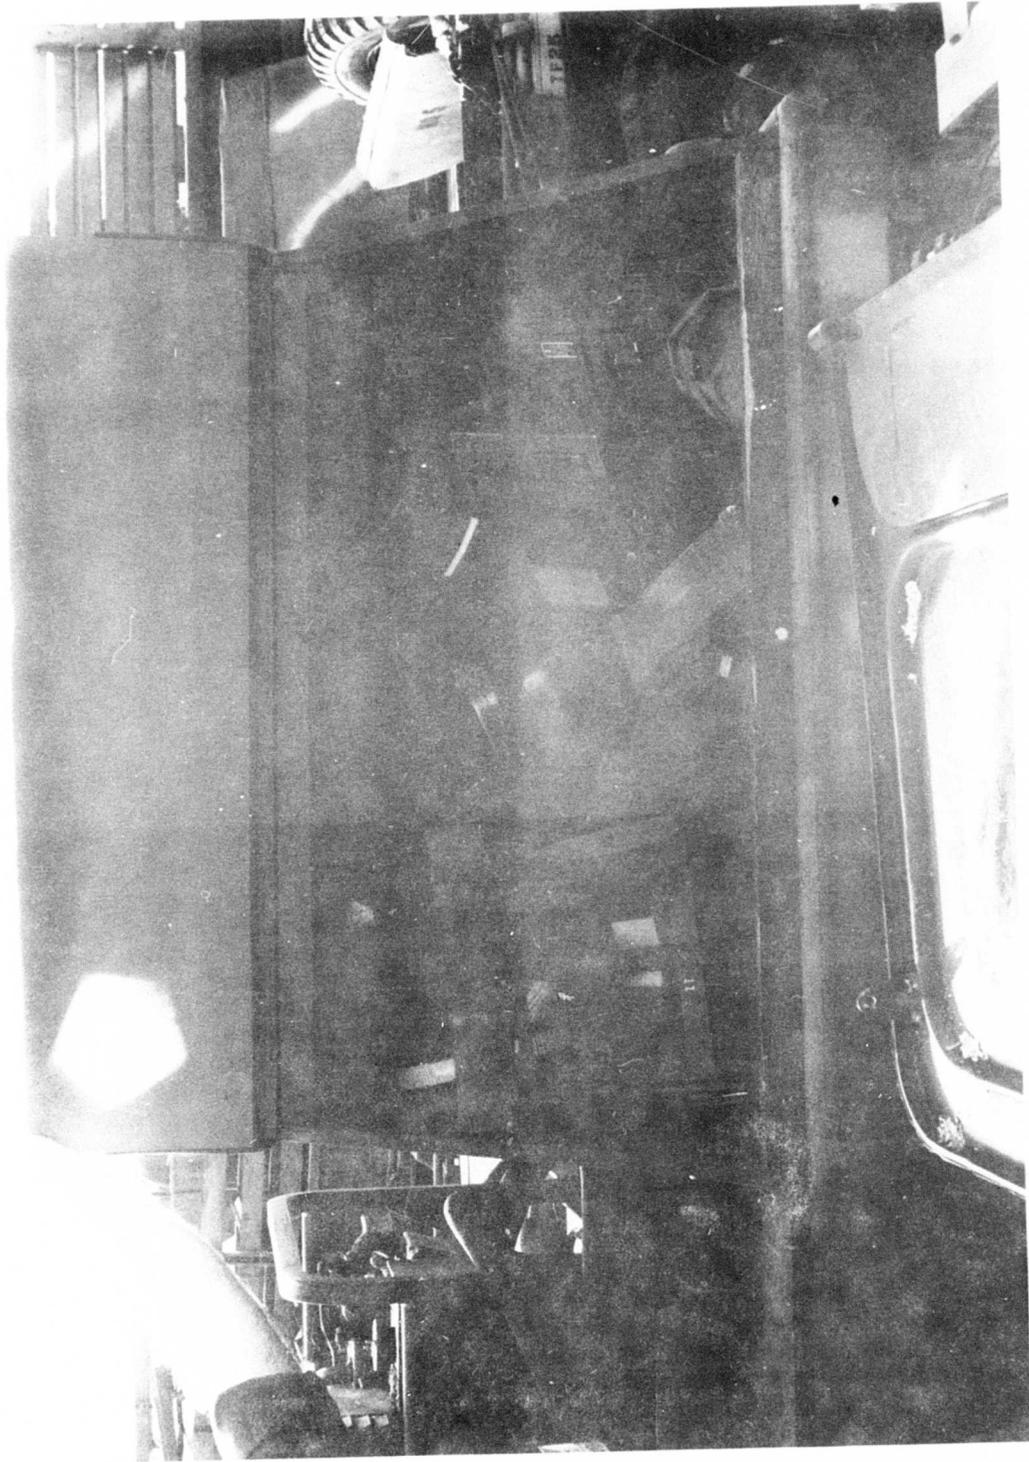
Figure 8-4. Unsecured radios in modified trailer.

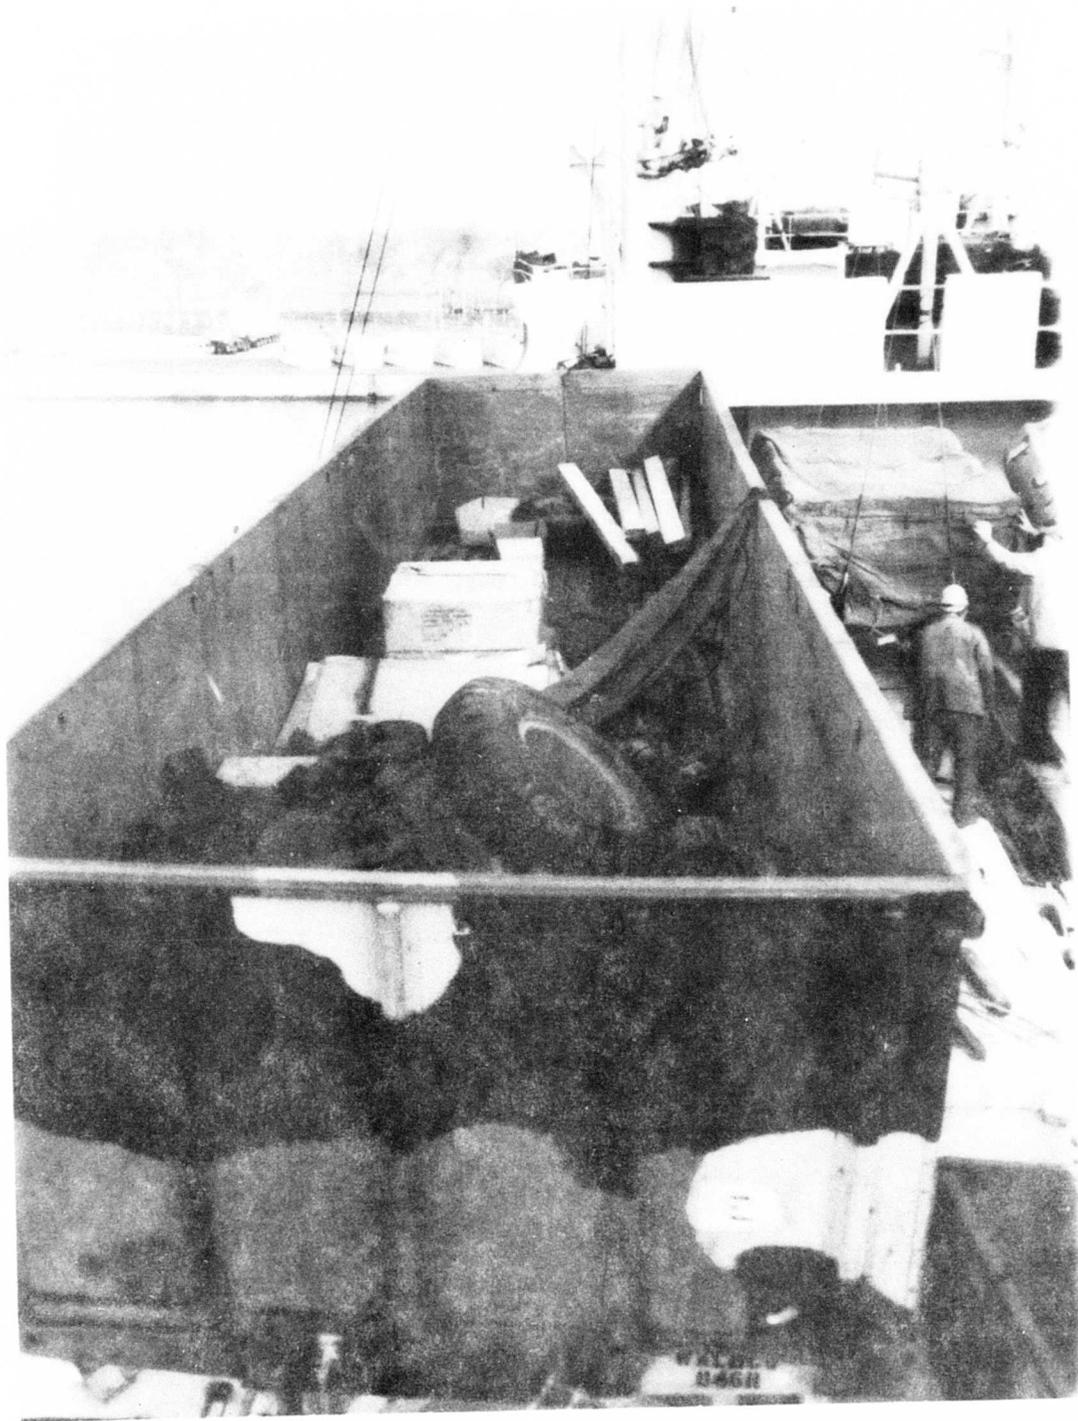
Figure 8-5. Unsecured cargo in S&P trailer.
