MTMC REPORT OA 81-4a-27

ANALYSIS OF MTMC PARTICIPATION IN THE REFORGER 81 EXERCISE

MAY 1982

MILITARY TRAFFIC MANAGEMENT COMMAND
TRANSPORTATION ENGINEERING AGENCY
 NEWPORT NEWS, VIRGINIA 23606

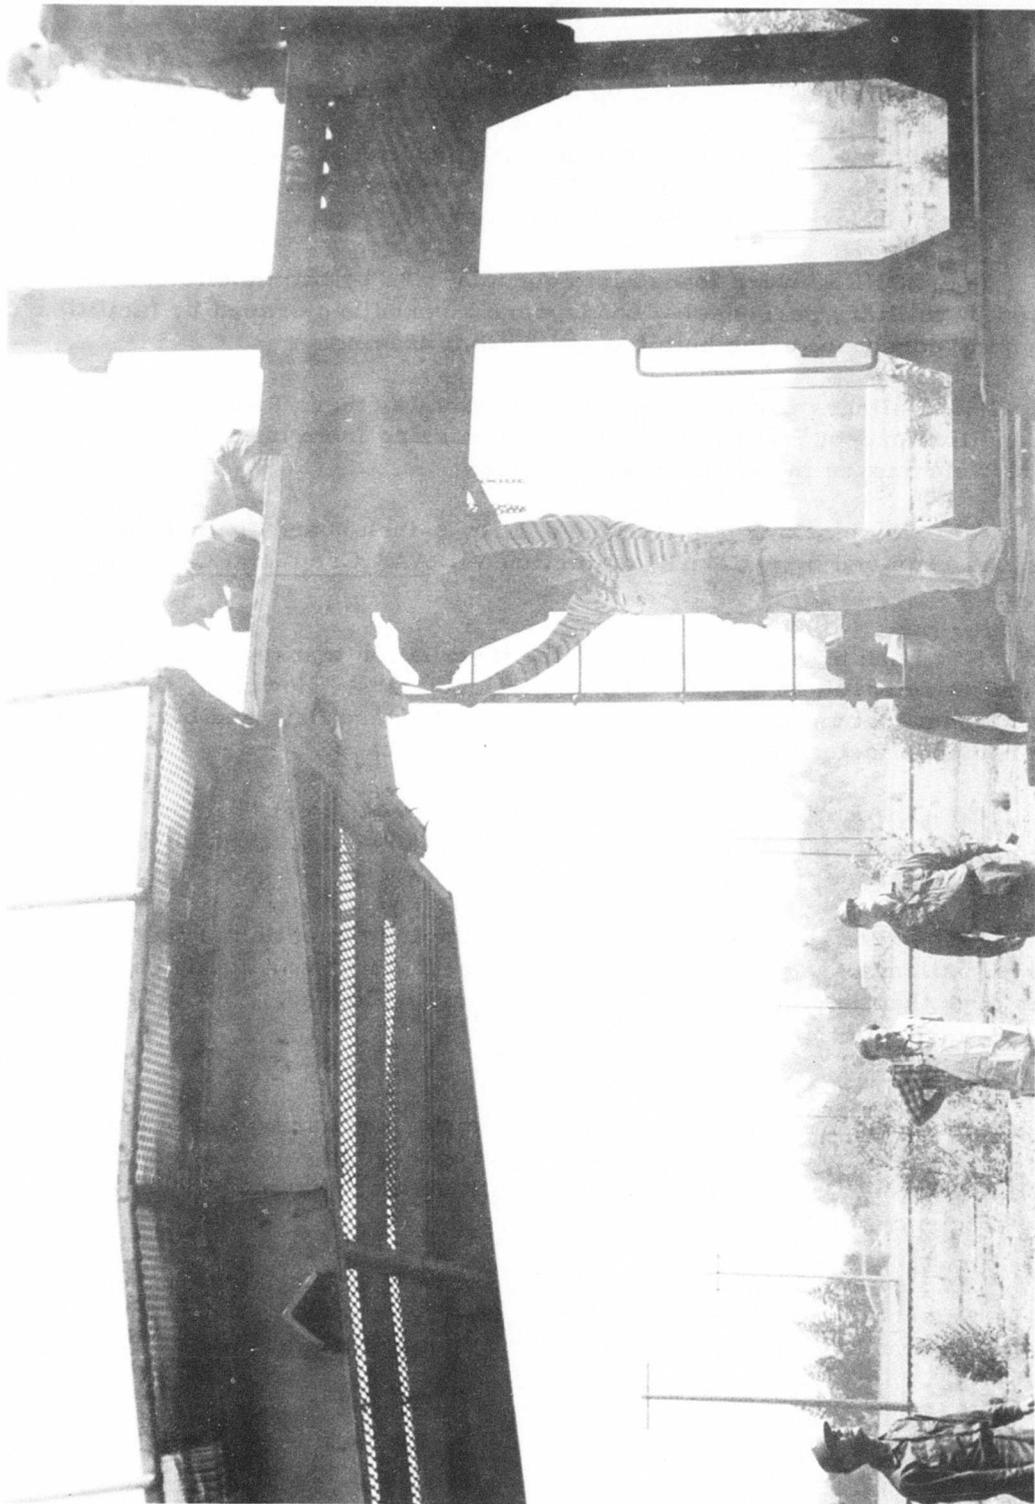
Figure 4-1. Fort Lewis bilevel rail-loading ramp.

(3) Vehicles were driven up a permanent end ramp and were loaded circus style onto standard flatcars. Bilevel cars were loaded by use of a mobile bilevel ramp. This ramp was not fully functional, requiring some onsite maintenance the first day of loading. Wooden spanners were used to span the gap between the bilevel ramp and railcars (fig 4-1).

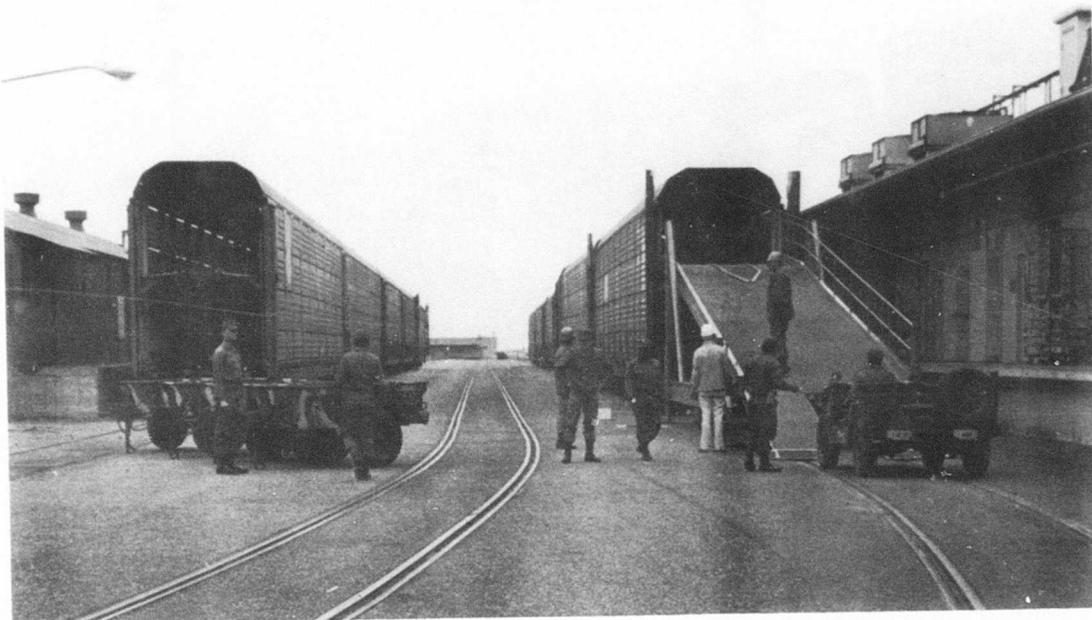
Figure 4-3. Fort Ord bilevel rail-loading ramp.

(2) Circus-style loading procedures were used for wheeled vehicles. A new bilevel ramp was used to load the bilevel cars (fig 4-3). Permanent ramps were used at both the balloon spur and the 11th Street spur. Vehicles were called forward to the rail spurs by hand-held radios.

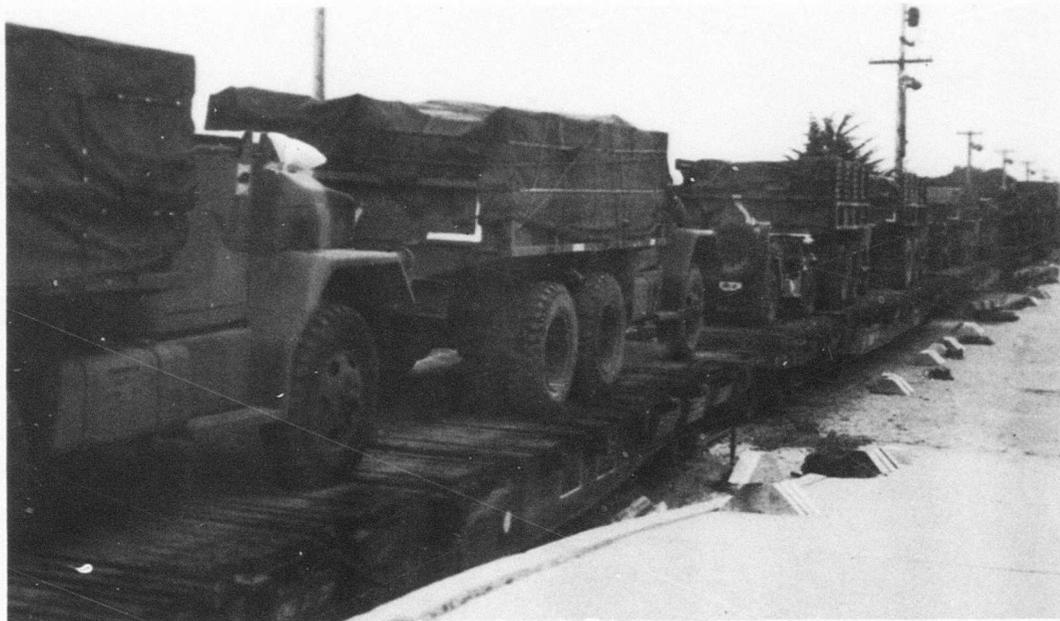
Figure 4-4. Fort Ord cargo beds fully used.

(9) Cargo was loaded into the beds of trucks and trailers, vehicles were reduced to shipping configurations IAW AR 220-10 (fig 4-4), and thus, the CONEX rail requirement was reduced from 47 to 8 CONEXs. Cargo was well secured in the cargo beds and was covered with tarps.

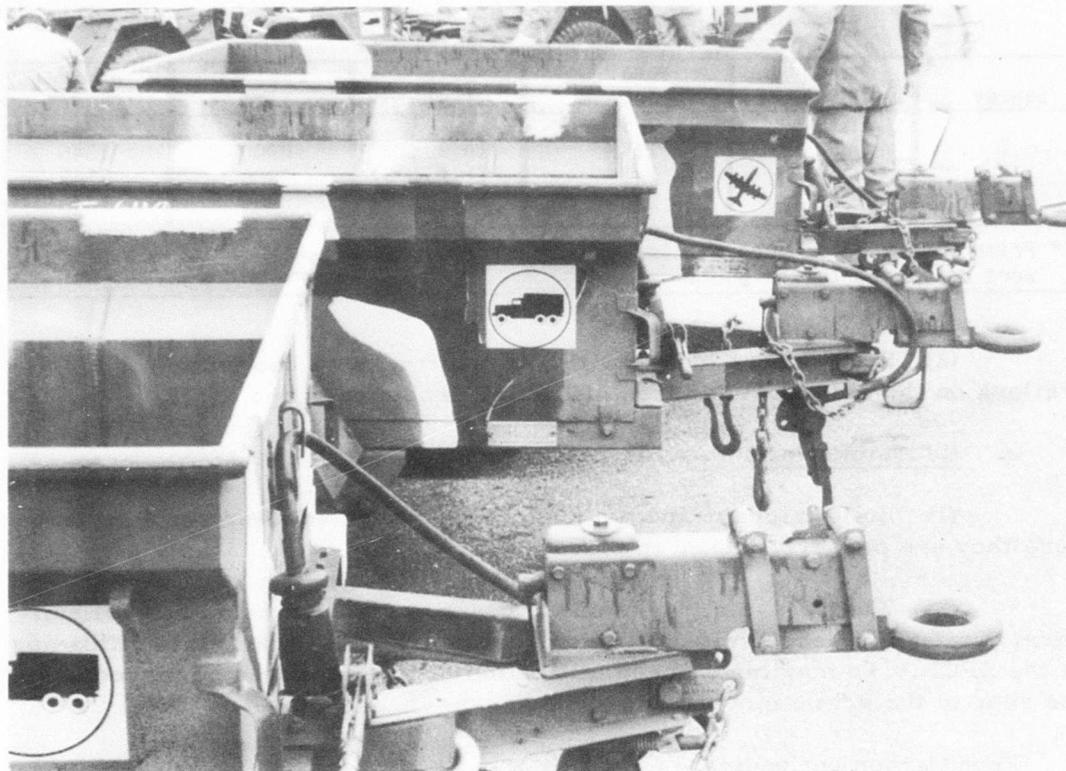
Figure 4-5. Plastic SPOD mode-designation stickers.

(11) The markings required by the REFORGER planning group to designate the mode of transportation at SPOD for convoy, sea/air interface, or rail movement were silk-screened onto plastic stick-on patches that were applied to the sides of the vehicles (fig 4-5).

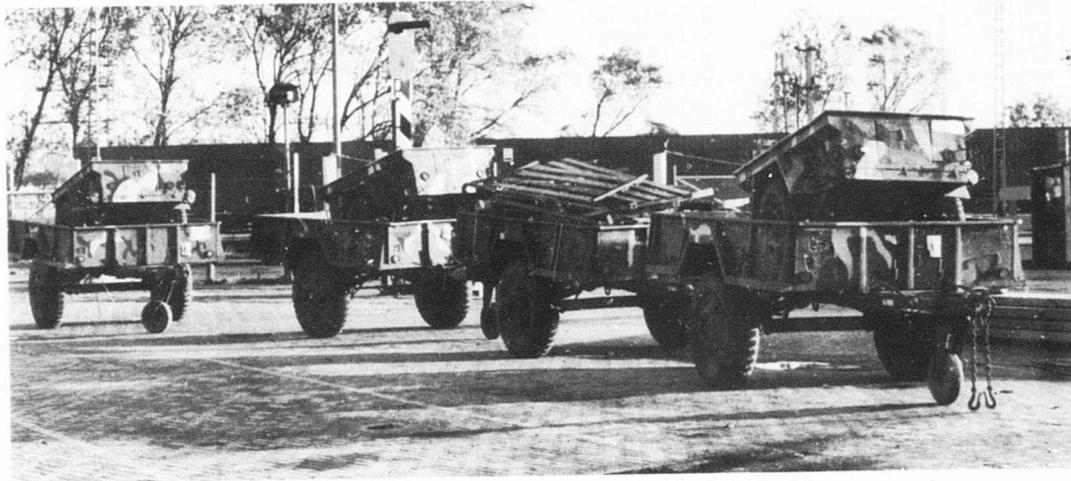
Figure 7-3. Smaller vehicles loaded onto larger vehicles.

(3) Since the ship mix changed, load planning had to be redone for four breakbulk ships. The change in vessel types and the subsequent loss of cargo space influenced the decision to consolidate equipment by nesting empty trailers and by loading smaller vehicles onto the cargo beds of larger vehicles (fig 7-3).
